ROBERT L. BISHOP DAM

DELAWARE COUNTY, NEW YORK
INVENTORY No. NY 534

PHASE I INSPECTION REPORT NATIONAL DAM SAFETY PROGRAM

NEW YORK DISTRICT, CORPS OF ENGINEERS
MAY 1981

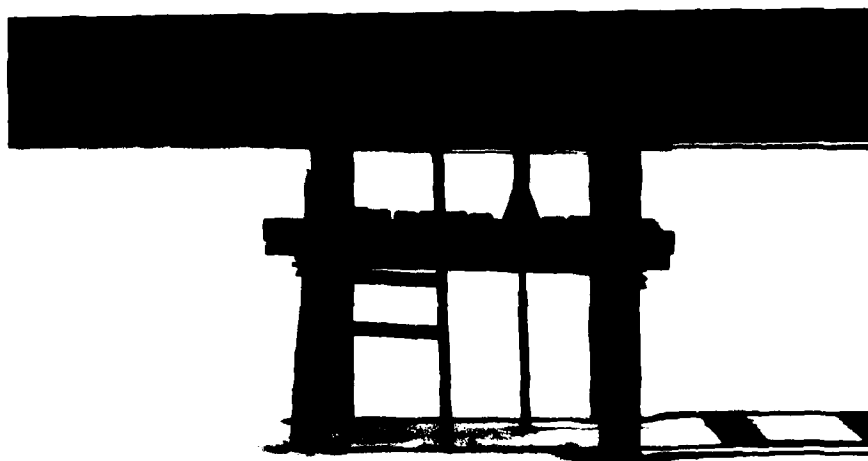
The drop inlet is a 30 inch corrugated metal pipe (CMP) with an anti-vortex baffle plate. The drop inlet structure appeared to be in good condition at the time of the inspection; however, it has rusted somewhat (See Photo No. 10). The gate stem for the low level reservoir drain was observed but not operated during the inspection (See Photo No. 11).

PHOTO #11: Impoundment drain operating gate
